Nov 4/97

FIELD AMENDMENT NOTICE

SNOW DETECTOR WIRING CORRECTION

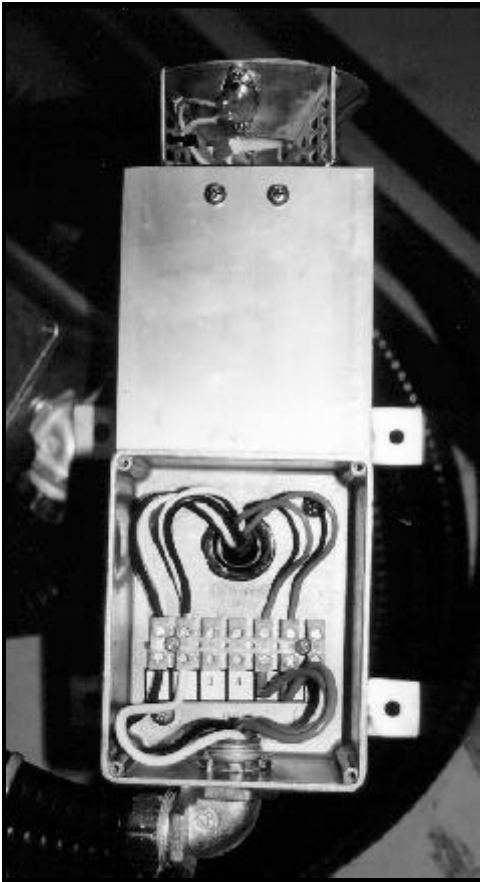
Remove junction box cover to access terminal strip. (Wiring shown is correct).

Correct the wiring by

- 1) Pairing a white from the cone heater with a black wire from the grid heater (wires 1 and 3) and place them into terminal 1. Take the remaining black and white wire pair (wire 2 and 4) and place them into terminal 2.
- 2) Remove the white jumper wire between terminal 1 and 2.
- 3) Remove the black jumper wire between terminal 3 and 4.
- 4) Connect the black and white leads from the conduit whip to terminals 1 and 2 respectively.

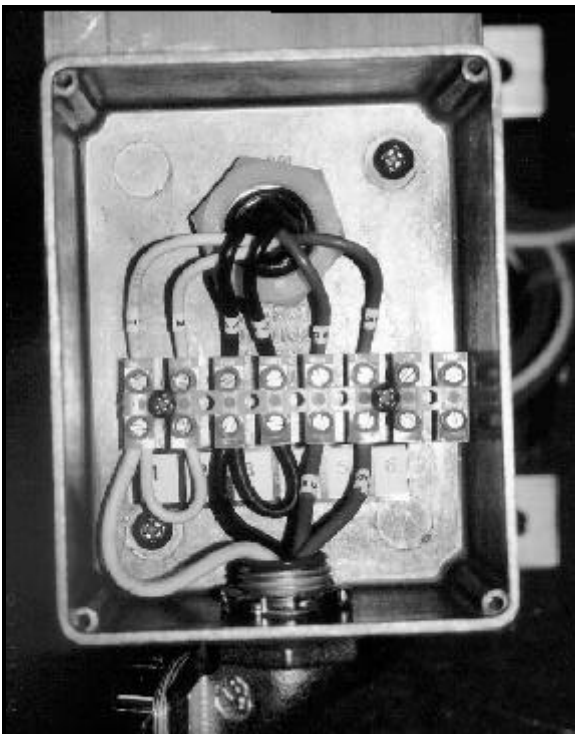
Incorrect wiring

We have identified a snow detector cone and grid heater wiring error. Detectors with this error will not melt and detect snow.
