Hovey
Industries Ltd.

Field Amendment Notice 02-001

SUBJECT:	Incorrect wiring of Hellfire 400 switch heater motors.		
CONCERN:	Thermal overload relay will not function.	DATE	Jan 24 2002

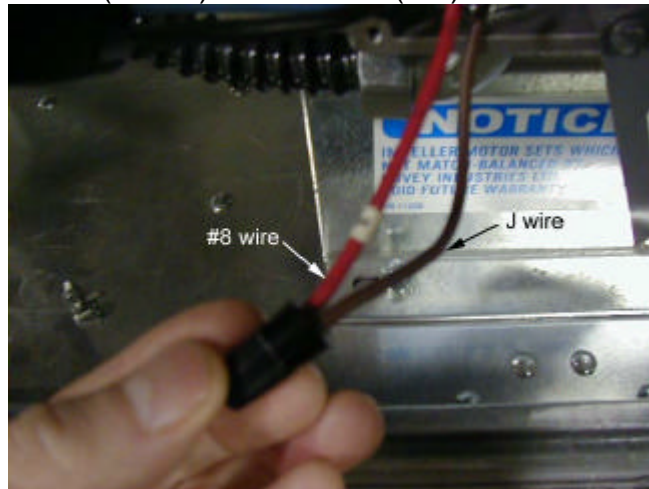
Motor wiring is done incorrectly and bypasses the thermal overload relay. If the motor overloads and overheats, it will eventually fail.

J wire (brown) and #8 wire (red)

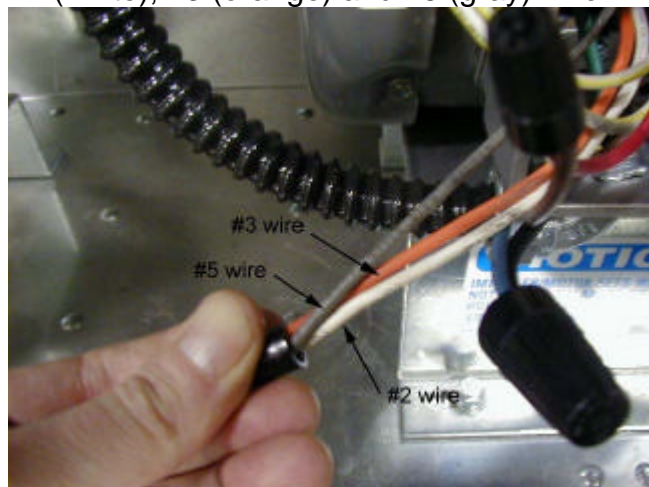
#2 (white), #3 (orange) and #5 (gray) wire

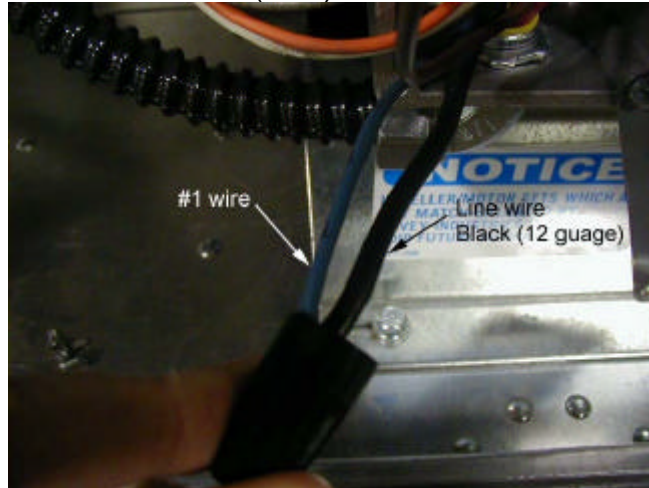
Line wire and #1 (blue) wire

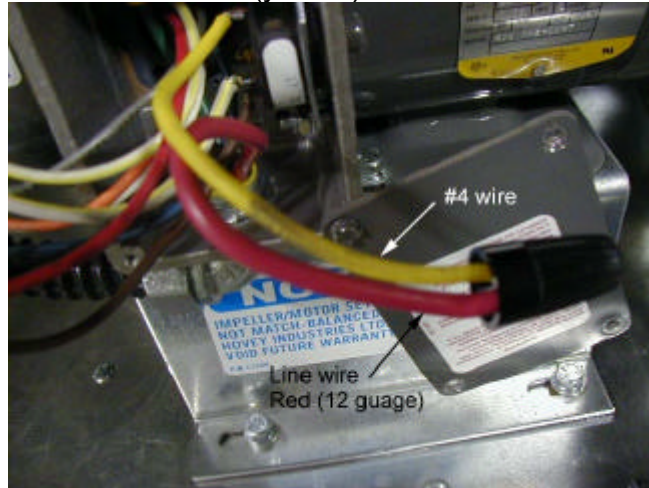
Line wire and #4 (yellow) wire

If the motor is connected as shown, reconnect as per instructions in the Corrective Action section.
