Field Amendment Notice 12340

SUBJECT:	Flame rods, Maxon/Auburn part number FRS-4, Hovey part number 14978		
CONCERN:	Occasional nuisance shut downs due to loss of flame signal.	DATE	Apr 15, 2002

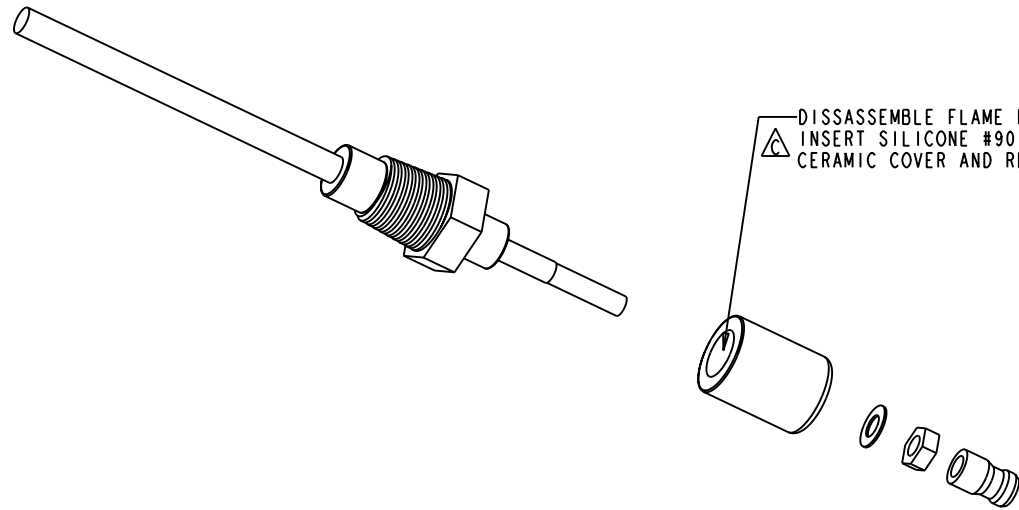
TITLE ROD, FLAME MOD'D 3" LG, 1/4" NPT	DRAWING NUMBER	REV. C
	14978	SHT. 1/1

Models Affected:	All Heaters manufactured between 1997 and 2001
Problem	Water can accumulate in the seam of the two piece flame rod ceramic creating a short circuit between the rod and ¼ NPT mounting bushing (ground).
Corrective Action	Dismantle the flame rod as shown on drawings 14978 and insert Dow Corning 3165 fast tack RTV adhesive silicone or equivalent inside ceramic cap and reassemble flame rod. This will ensure that no water can accumulate and create a short.

DISASSEMBLE FLAME ROD AS SHOWN.
INSERT SILICONE #9014-0047 INSIDE
CERAMIC COVER AND REASSEMBLE.
