Hovey
Industries Ltd.

Field Amendment Notice 12341

SUBJECT:	Leaking thermostat cover, Hovey part number 17320	DATE	Apr 19, 2002
CONCERN:	Nuisance shut downs due to false high limit thermostat alarm.

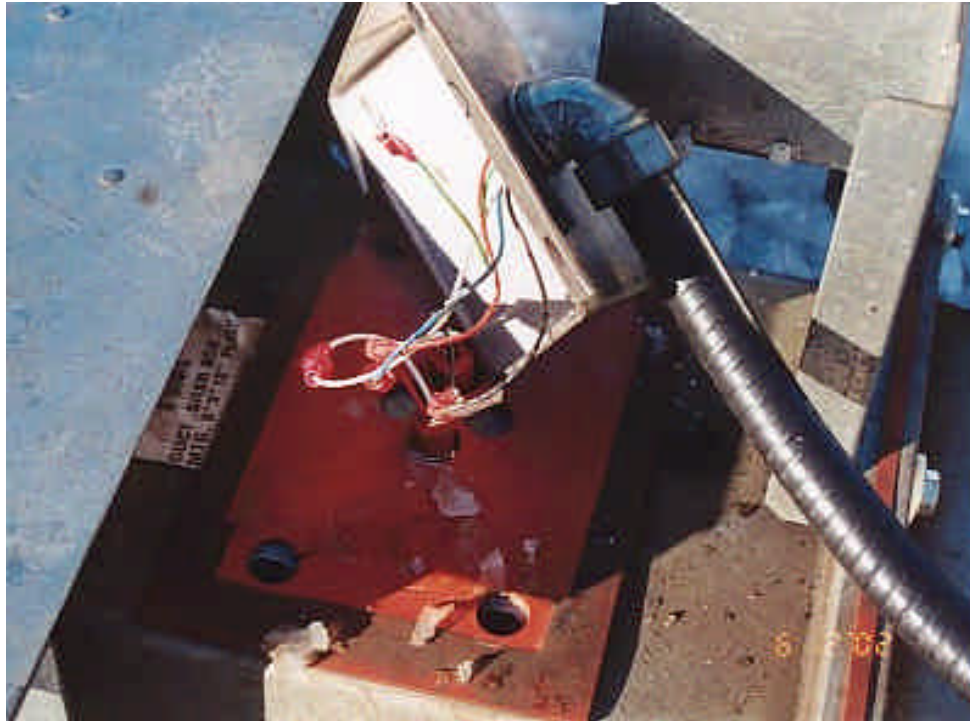
Reports have been received this winter of moist air leaking into the thermostat cover, from the sensor duct, condensing and short circuiting the 120V lead of the high limit thermostat to ground. The amount of current leakage is enough to put the LOGO PLC into alarm, but not enough to pull up the high limit relay.

Typically, the heater is reported in alarm by dispatch. The maintainer finds the heater alarm contact closed, but the alarm light is not lit (because the high limit relay does not close). Resetting the heater requires turning the power off then back on.

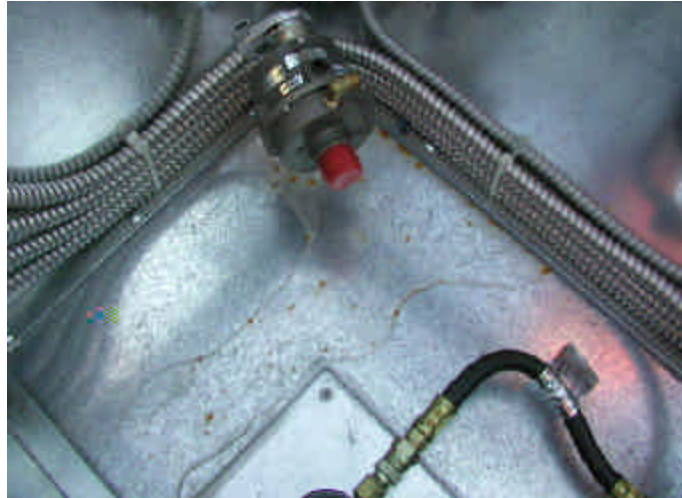
Signs of moisture inside the electrical /gas enclosure, is another indication of the problem. This is caused as a result of moist air travelling up the thermostat conduit and condensing inside.
