2793 Fenton Rd. Tel: (613) 822-1765
Gloucester, Ontario Fax: (613) 822-1556
K1T 3T9 Home Page: WWW.HOVEY.CA

FIELD AMENDMENT NOTICE

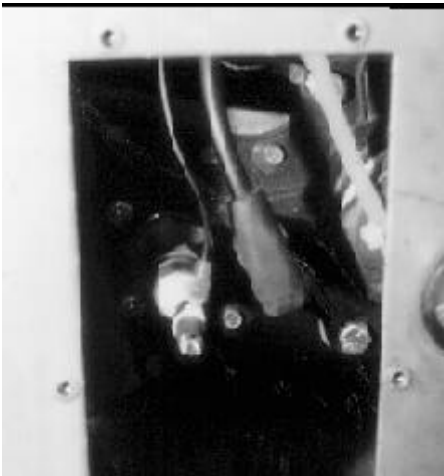
Present flame rod wiring (on left)
